Monitoring Data RecordProject Title: B-4183COE Action ID: 2011-00417 DWR Number: 20110060Stream Name: Crooked Creek and Middle Fork CreekCity, County and other Location Information: Madison County, replaced Br. #29 over Middle Fork Creek and Br. #28 over Crooked Creek on SR 1526 adjacent to US 19Date Construction Completed: Completed Planting on 11-26-12 Monitoring Year: (5) of 5Ecoregion: Broad Basins 8 digit HUC unit 06010105USGS Quad Name and Coordinates: 35.85350, -82.48853**Rosgen Classification:**Length of Project: 107' Urban or Rural: Rural Watershed Size: 7.6 sq. mi.Monitoring DATA collected by: M. Green & B. Bradley Date: 7/12/16

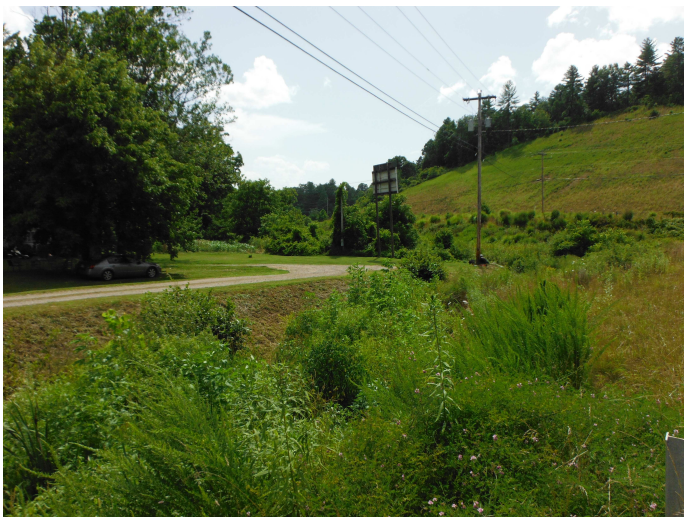
Overview Photo Looking Downstream of Crooked Creek from Crooked Creek Rd

The Crooked Creek stream relocation is stable for the Year 5 evaluation. The right bank of Middle Fork Creek at the confluence of Crooked Creek and Middle Fork Creek is also stable for the Year 5 evaluation. NCDOT proposes to discontinue channel stability monitoring at the Crooked Creek and Middle Fork Creek sites.
